# HAMS Fashion Ltd

Dakkhin Vanganahati, Sreepur, Gazipur-1740.  
(24.193231N, 90.457894E)  
28<sup>th</sup> January 2019

# Observations

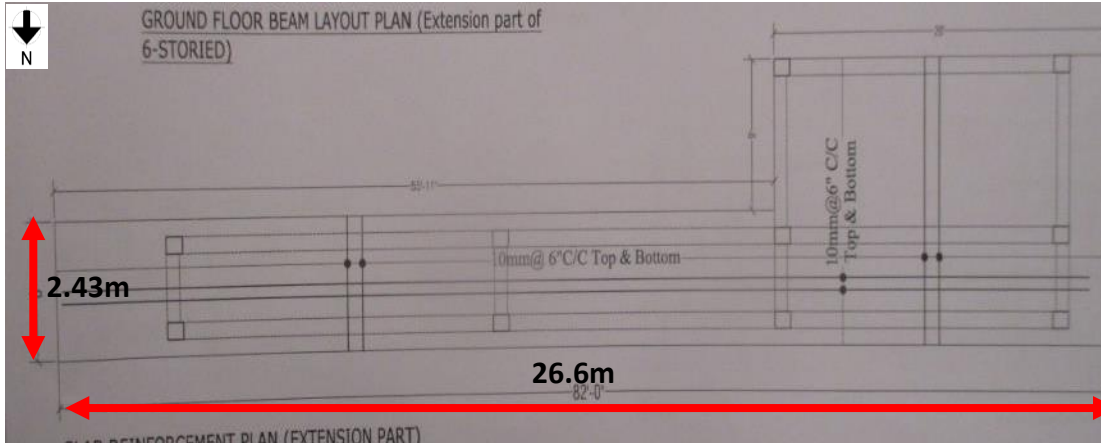
Slab detail of Extended part

Factory engineer to check lateral stability of the building against lateral load combination for poor aspect ratio. The structural arrangement in tall slender building (ht-11.3m) may result in net tension in structural element.

| Item No. | Observation | Recommended Action Plan | Recommended Timeline |
|---|---|---|---|
| 1 | Apparent lack of lateral stability. (Factory Building) | Factory engineer to check the stability of the structure under vertical and horizontal loads. | 6-weeks |
| 2 | Apparent lack of lateral stability. (Factory Building) | Carry out remedial works resulting from engineering assessment if necessary. | 6-months |

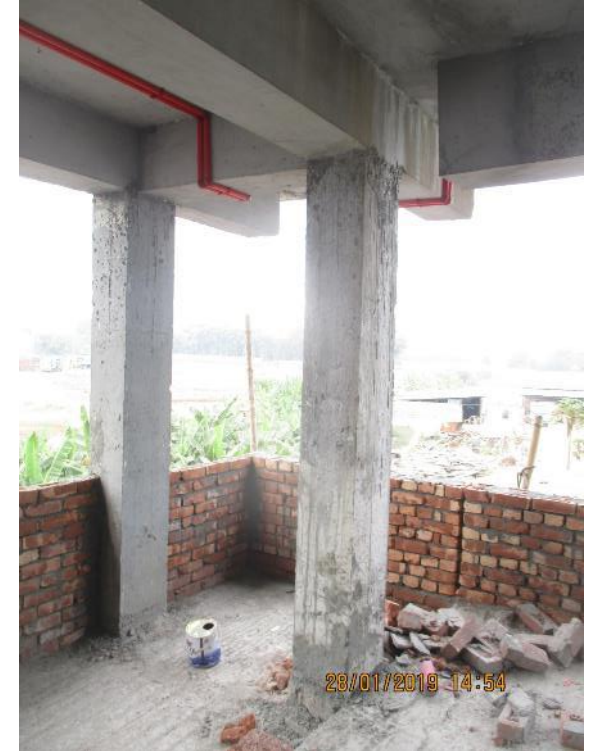
Columns of short direction

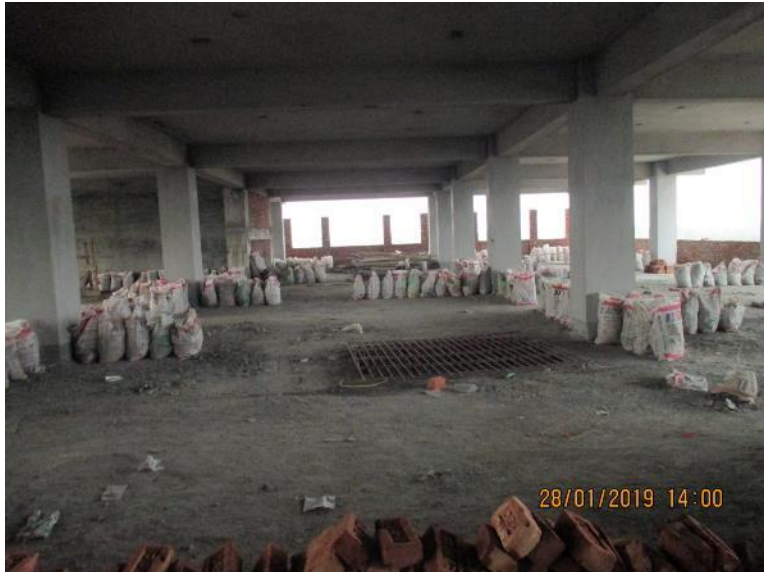
Stack of construction debris on 5<sup>th</sup> floor

Most of floors were not occupied till the inspection day. Factory is required to maintain floor live load plan and implement load management program (posting the load plan & load height restriction signage) as per its floor loading capacity (5kPa) after occupying the floors. Follow the load plans for all floors and make sure that the workers understand the loading requirements.

| Item No. | Observation | Recommended Action Plan | Recommended Timeline |
|---|---|---|---|
| 3 | Implement floor load management program. (Factory Building) | Factory is required to implement load management program (signage, load restriction height marking) as per its floor load plan. | 6-weeks |
| 4 | Implement floor load management program. (Factory Building) | Continue to implement load plan. | 6-months |

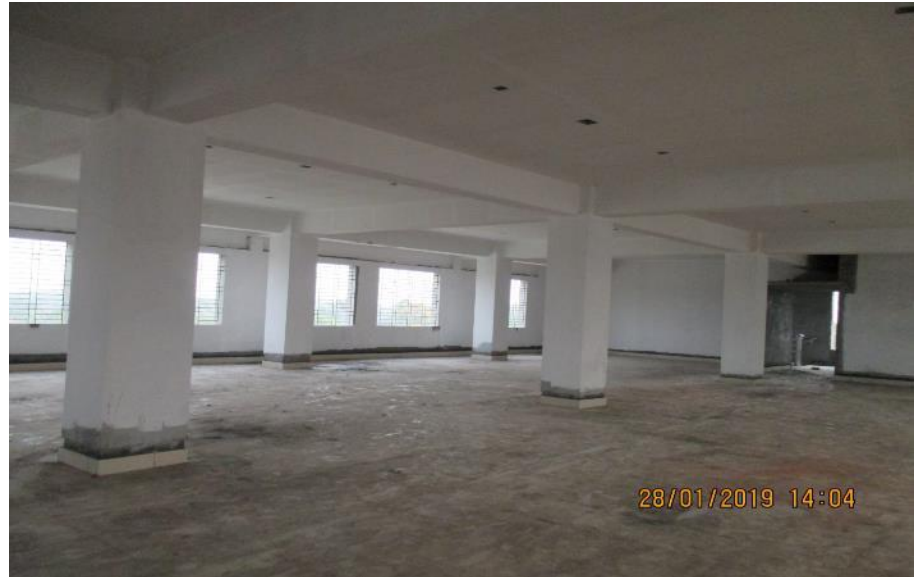
Unoccupied 4<sup>th</sup> floor

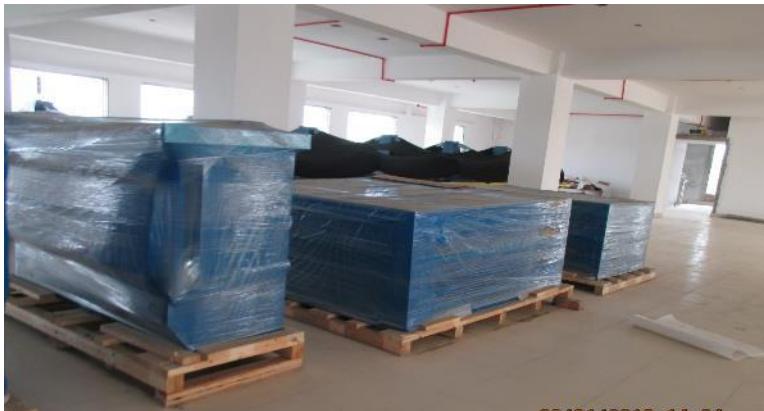
Unpacked machineries on 3<sup>rd</sup> floor

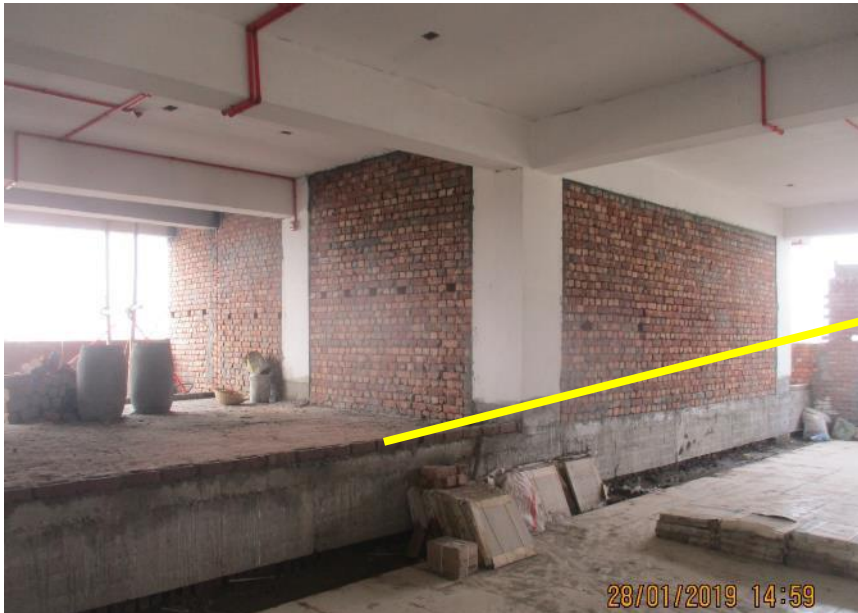
Different slab height on 1<sup>st</sup> floor

Different height floor slab with beam was observed on 1<sup>st</sup> floor but no detail was found in as-built drawing. Factory is required to update the as-built drawing to show the elevation difference.

| Item No. | Observation | Recommended Action Plan | Recommended Timeline |
|---|---|---|---|
| 5 | Lack of information in As-built drawing. (Factory Building) | Factory engineer is required to survey all the structural elements properly and produce correct as built drawings which reflect the on site condition. | 6-weeks |

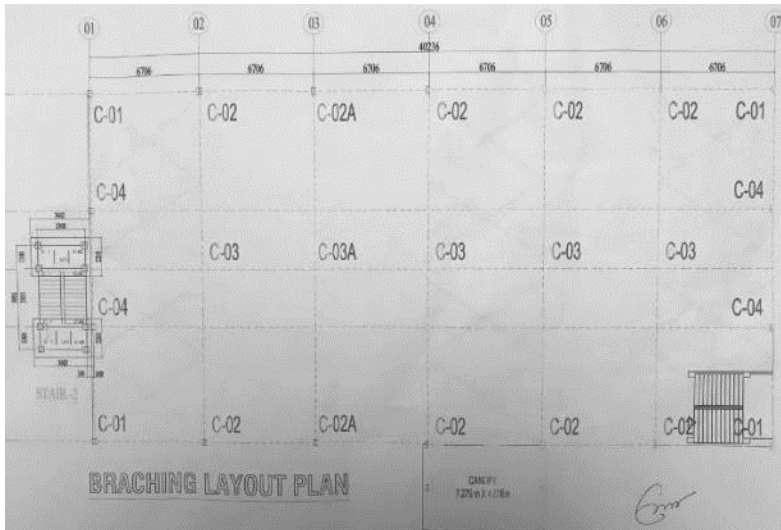
Roof bracing layout in Retrofitting drawing

On site roof bracing matched with retrofitting drawing but not with analysis model. In addition, most of the welding on retrofitted section were appeared to be improper. Factory is required to revise the design report according to on site condition and include the remediation plan for the improper welding and submit to ACCORD for further review.

| Item No. | Observation | Recommended Action Plan | Recommended Timeline |
|---|---|---|---|
| 6 | Design Report required to be reviewed by Accord. (Printing Building) | Complete review of Design report by Accord. | 6-weeks |
| 7 | Design Report required to be reviewed by Accord. (Printing Building) | Complete remedial works coming from detail engineering assessment after reviewing by Accord. | 6-months |

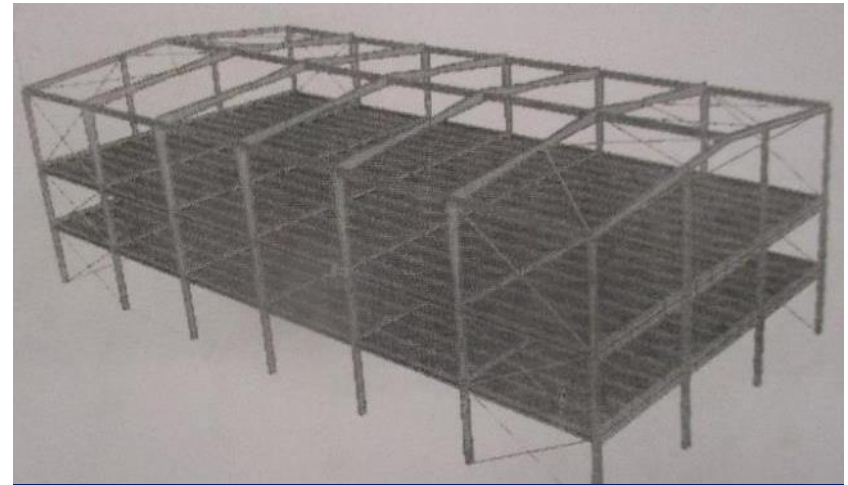
Bracing shown in Render view of analysis model

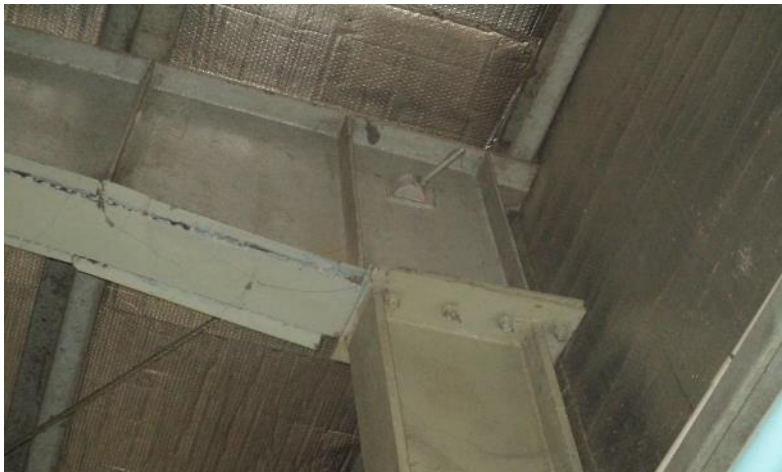
Improper welding was observed in retrofitting location on rafter on various location

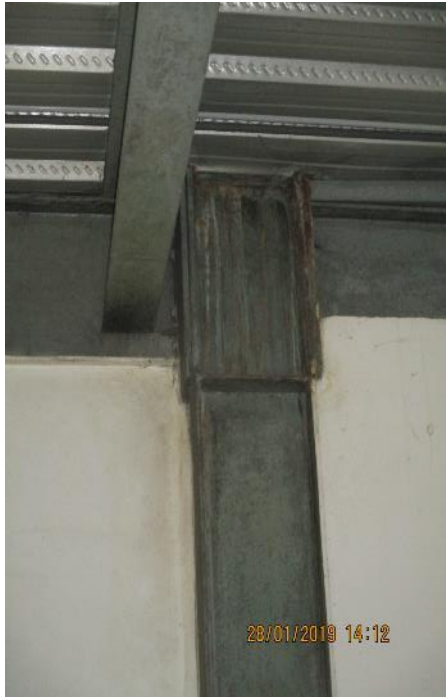
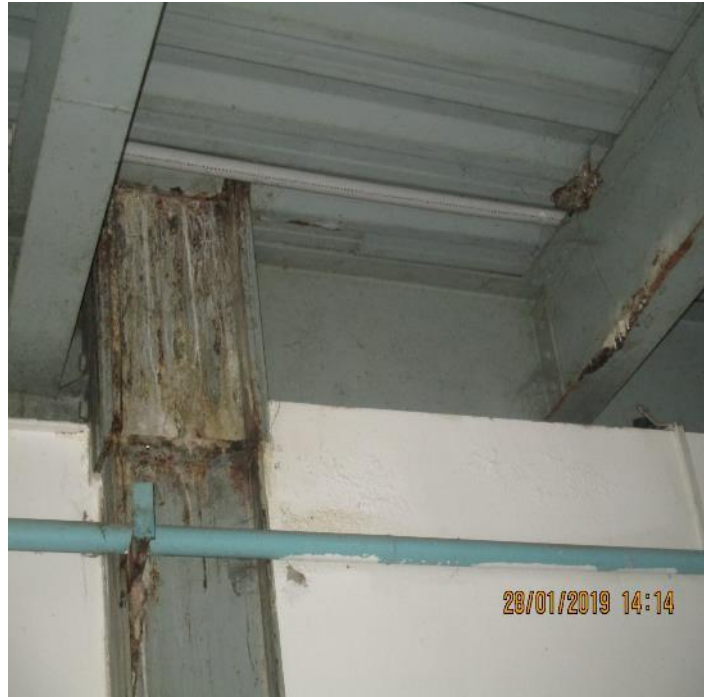
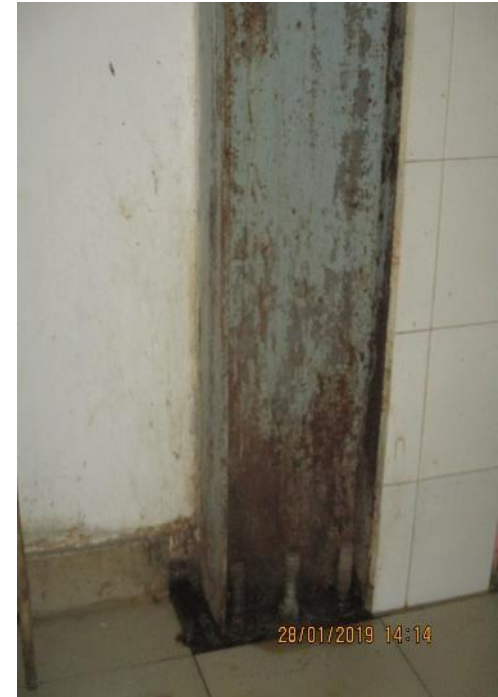
Corrosion was observed at beam-column joint of steel members. Corrosion was observed on the bottom part of ground floor column. Most of the corroded steel members were found under the toilet area. Factory is required to identify all the corroded locations and take proper remedial measures.

| Item No. | Observation | Recommended Action Plan | Recommended Timeline |
|---|---|---|---|
| 8 | Corrosion observed at steel sections. (Printing Building) | Factory Engineer to suggest and implement proper remedial measures to protect steel sections from corrosion. | 6-weeks |

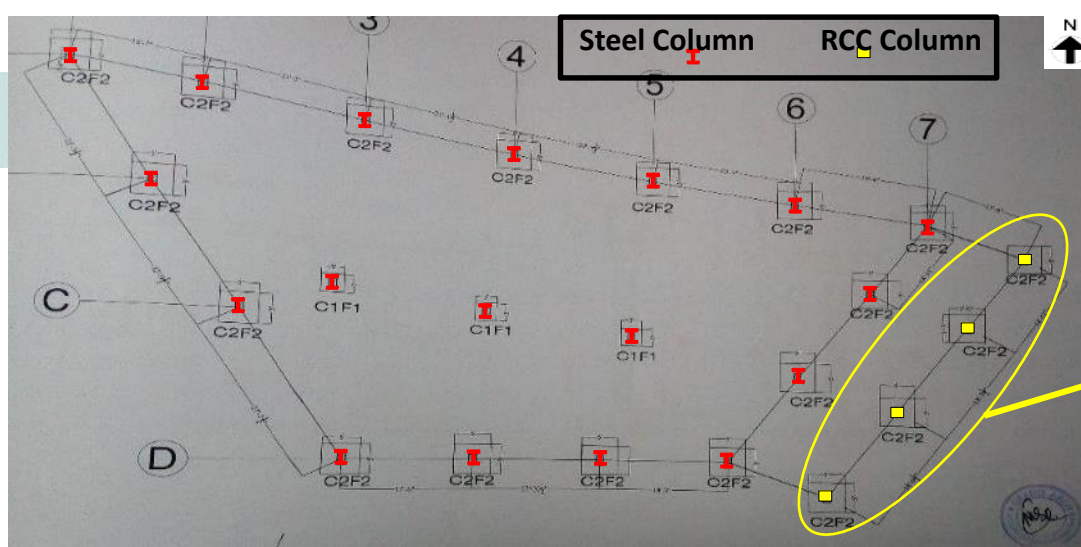
Column layout plan

On east side, RCC columns were found instead of steel columns. In addition, no frame section detail was found for the east side. On south side, the column was found as uniformed section (F-160mm x W-340mm) instead of tapered section and the dimension of north side was found (F-160mm x W- 300~360mm) instead on (F-190mm x W-238~438mm).

| Item No. | Observation | Recommended Action Plan | Recommended Timeline |
|---|---|---|---|
| 9 | Discrepancies between as-built drawings and on-site observation. (Warehouse) | Factory engineer is required to survey all the structural elements properly and produce correct as built drawings which reflect the on site condition. | 6-weeks |

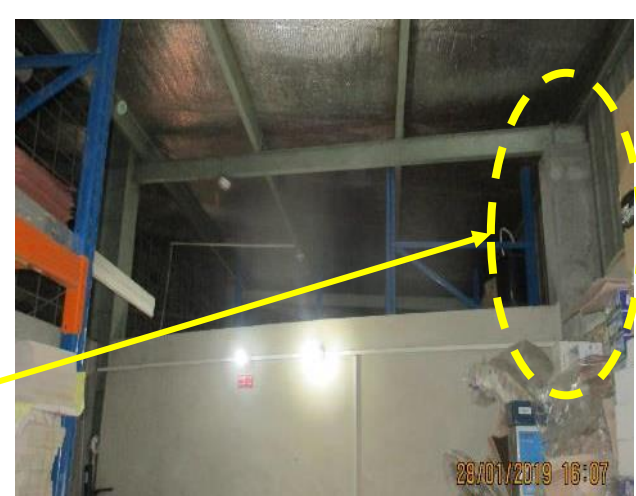
RCC column were found on east side

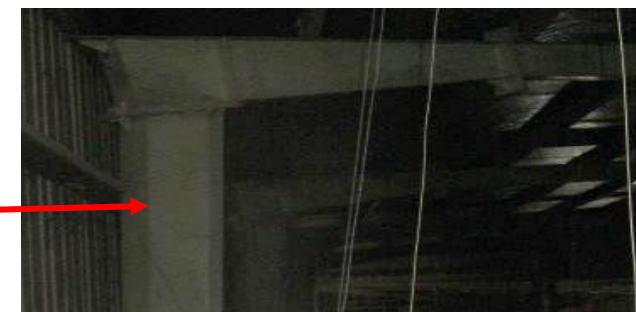
Uniformed section was found instead of tapered section

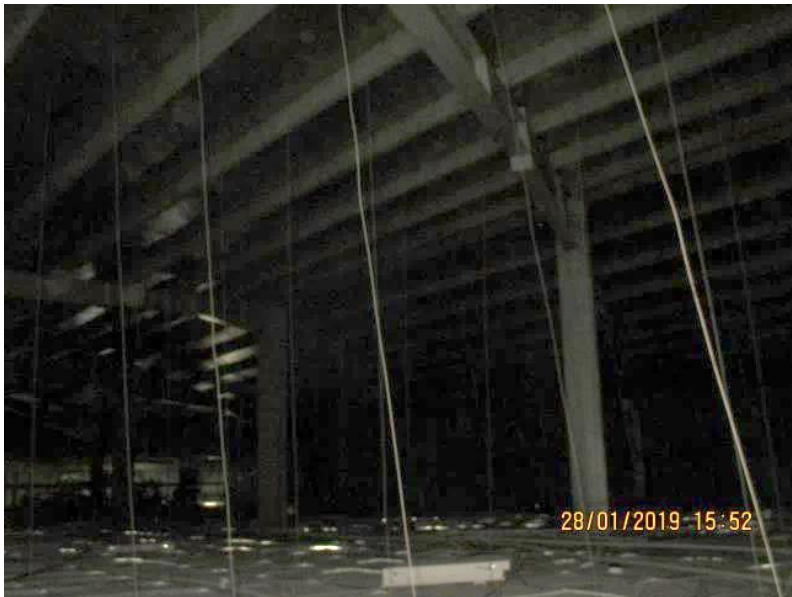
Steel frame (No Roof/Horizontal bracing)

All member connections are pin connection. No vertical or horizontal bracing were provided for lateral stability. Factory is required to check stability of roof shed against lateral loads.

| Item No. | Observation | Recommended Action Plan | Recommended Timeline |
|---|---|---|---|
| 10 | Lack of lateral stability. (Warehouse) | Factory engineer to check the stability of the structure under vertical and horizontal loads. | 6-weeks |
| 11 | Lack of lateral stability. (Warehouse) | Carry out remedial works resulting from engineering assessment if necessary. | 6-months |

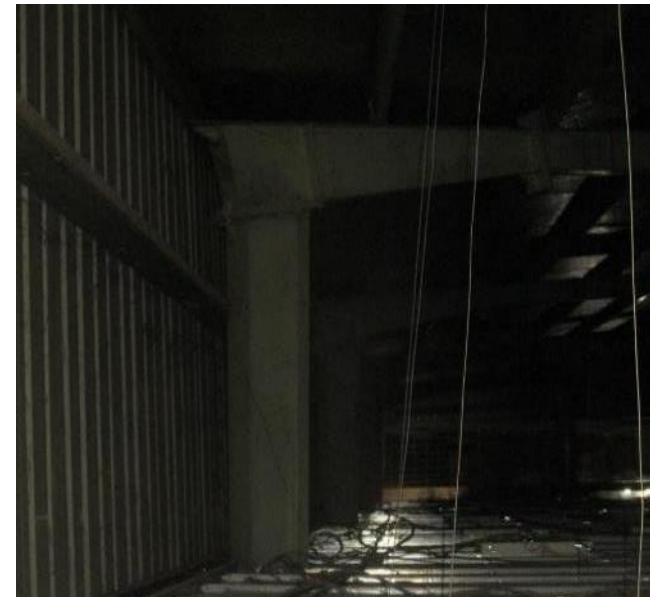
Steel frame (No vertical bracing)

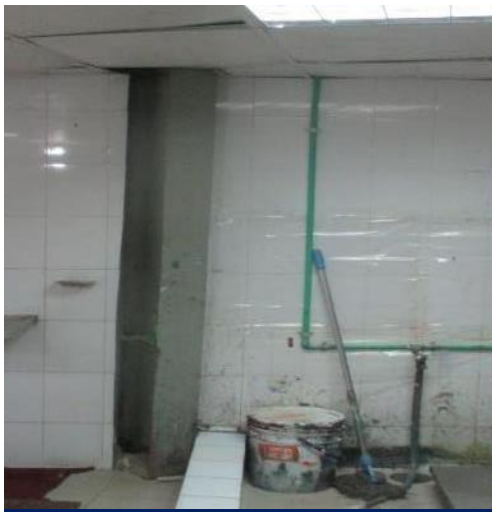
Steel columns were bolted

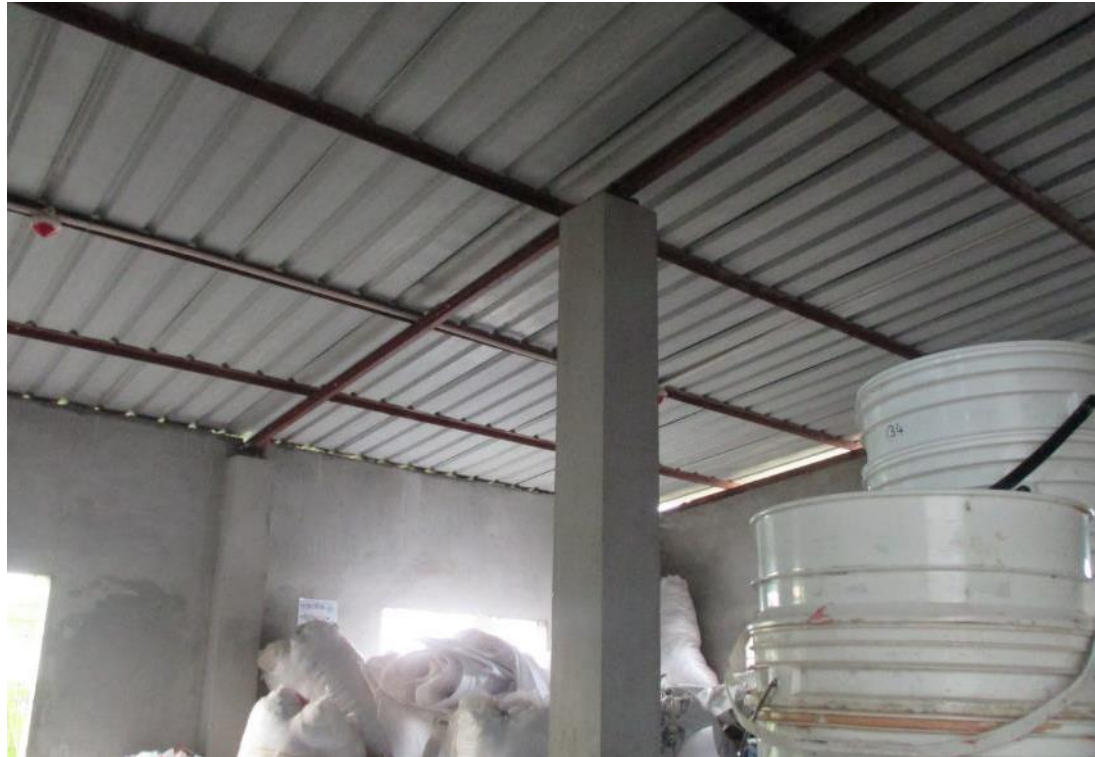
No detail of internal frame system was found in as-built drawing. Factory is required to update the as-built drawing to show the detail of internal frame.

| Item No. | Observation | Recommended Action Plan | Recommended Timeline |
|---|---|---|---|
| 12 | Lack of information in As-built drawing. (Fire Pump shed) | Factory engineer is required to survey all the structural elements properly and produce correct as built drawings which reflect the on site condition. | 6-weeks |

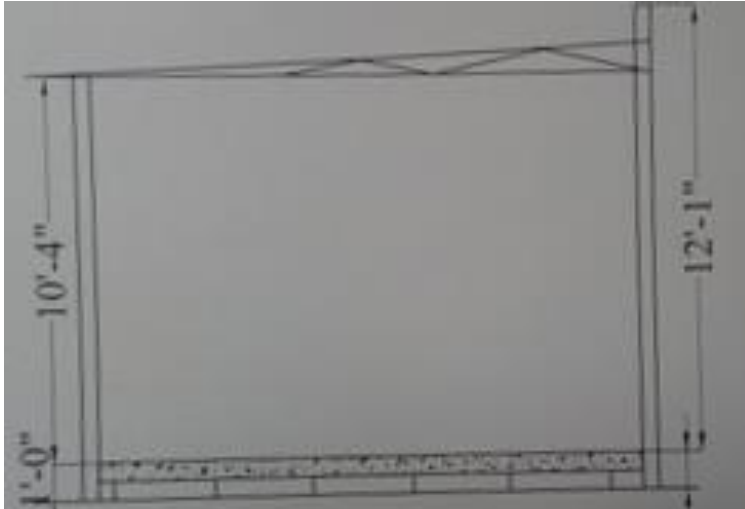
Typical framing system in as-built drawing

The internal framing system did not match with on site condition. Factory is required to revise the as-built drawing which reflecting the on site condition.

| Item No. | Observation | Recommended Action Plan | Recommended Timeline |
|---|---|---|---|
| 13 | Discrepancies between as-built drawings and on-site observation. (Day care shed) | Factory engineer is required to survey all the structural elements properly and produce correct as built drawings which reflect the on site condition. | 6-weeks |
