INITIAL STRUCTURAL INTEGRITY ASSESSMENT REPORT (SIAR)

Factory Name: **Needle Drop Ltd.**

Assessor: **Bureau Veritas**

Date: **12 Jun 2014**

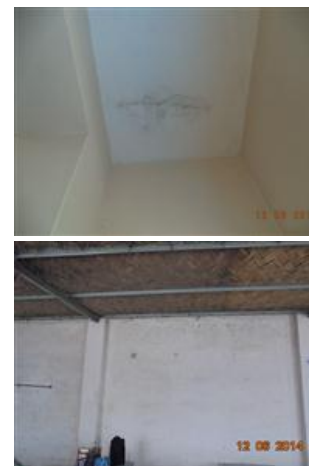
Question:	Are structural steel members free of corrosion, physical damage or other types of deterioration?
Priority Level:	Medium

Non-Compliance Level:	1
Description:	There are signs of corrosion in the steel members of the ancillary structure.
Source of Findings:	Visual Assessment: Confirmed visually.
Suggested Plan of Action:	Complete further testing on areas of deterioration and have a qualified structural engineer develop a remediation plan.
Suggested Deadline Date:	02 Aug 2014
Standard:	Alliance Standard Part 8 Section 8.26

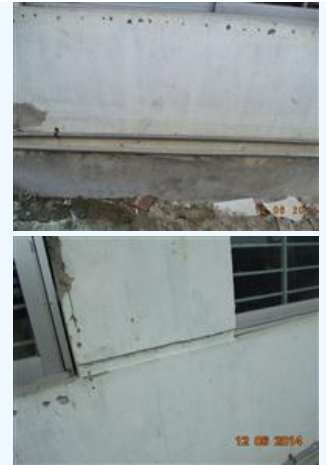
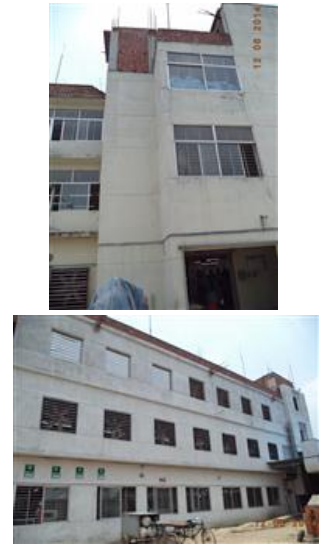
Question:	The exterior façade is free of cracking.
Priority Level:	Low
Non-Compliance Level:	1
Description:	Cracks have been identified at front side of the second level and at north side of ground level.
Source of Findings:	Visual Assessment: Confirmed visually.

Suggested Plan of Action:	Have a qualified structural engineer provide further analysis of the identified cracks to determine the appropriate course of corrective action.
Suggested Deadline Date:	02 Aug 2014
Standard:	Alliance Standard Part 8 Section 8.2
Question:	Is the building free of active signs of water intrusion or ponding due to lack of performance of the façade system?
Priority Level:	Low
Non-Compliance Level:	1
Description:	Dampness has been observed almost every side of the main building, especially on the main entrance side of the 2nd and 3rd level.
Source of Findings:	Visual Assessment: Confirmed visually.
Suggested Plan of Action:	Repair the exterior façade system to prevent water intrusion.
Suggested Deadline Date:	13 Sep 2014
Standard:	Alliance Standard Part 8 Section 8.26 Durability and Maintenance
