Ripon Knitwear Ltd. Ripon Packaging Ltd.

Jarun, Konabari, Gazipur
(23.994231, 90.323039)
23rd April 2014

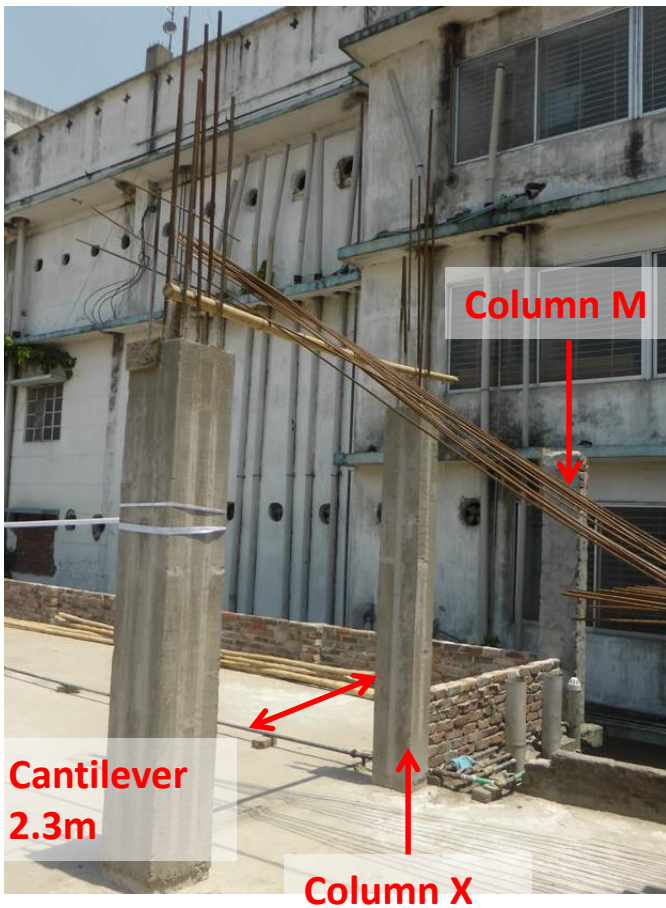
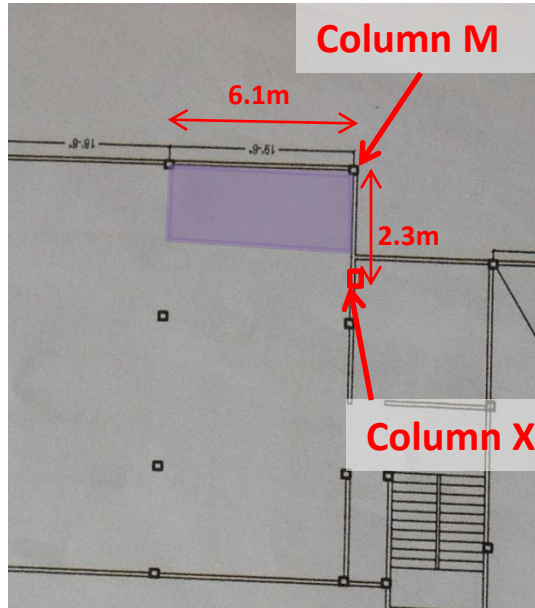
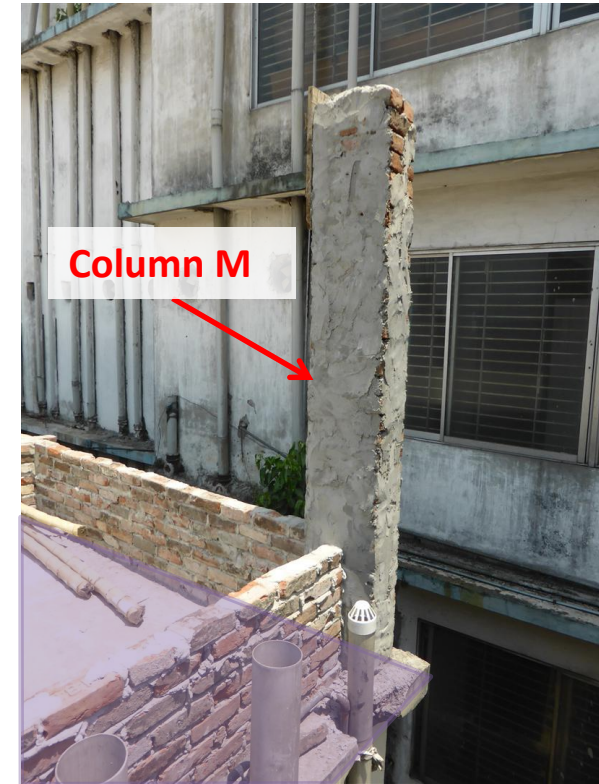
Rooftop vertical extension ongoing without any available design.

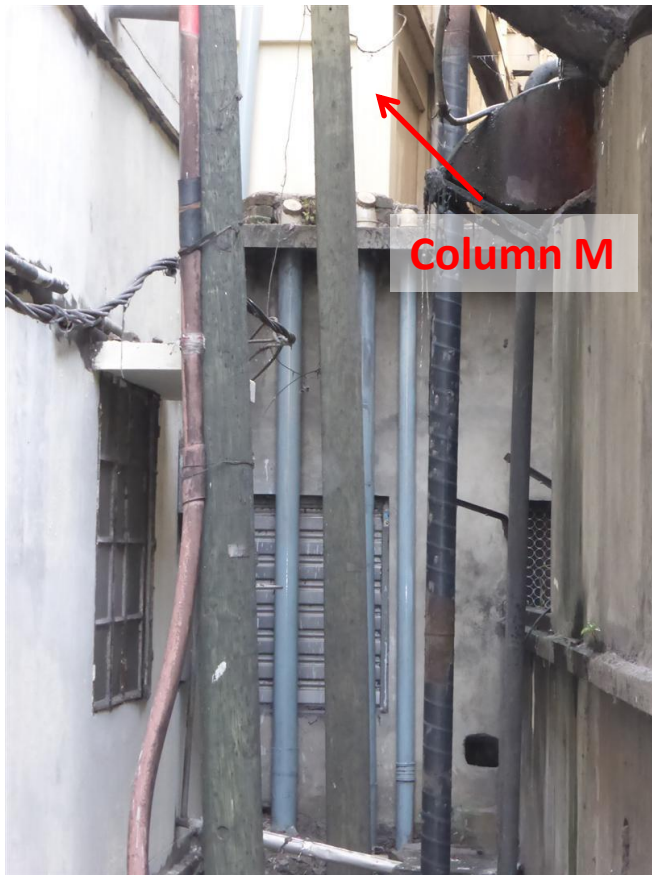
Structural arrangement observed on site does not match Permit Drawings. 'Column M' is constructed as a **masonry column**. No design information or details for approx 1.3m cantilever slab.

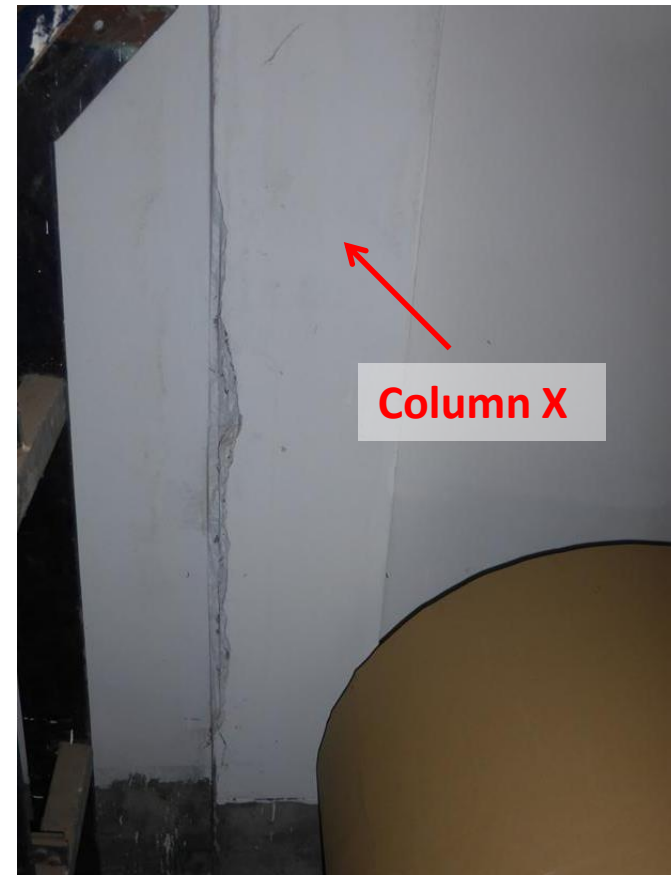
Continued construction at roof level will increase working stress in columns.

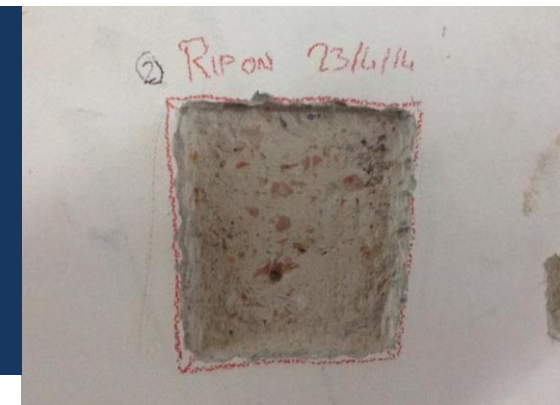
Highly stressed column for irregular structural arrangement

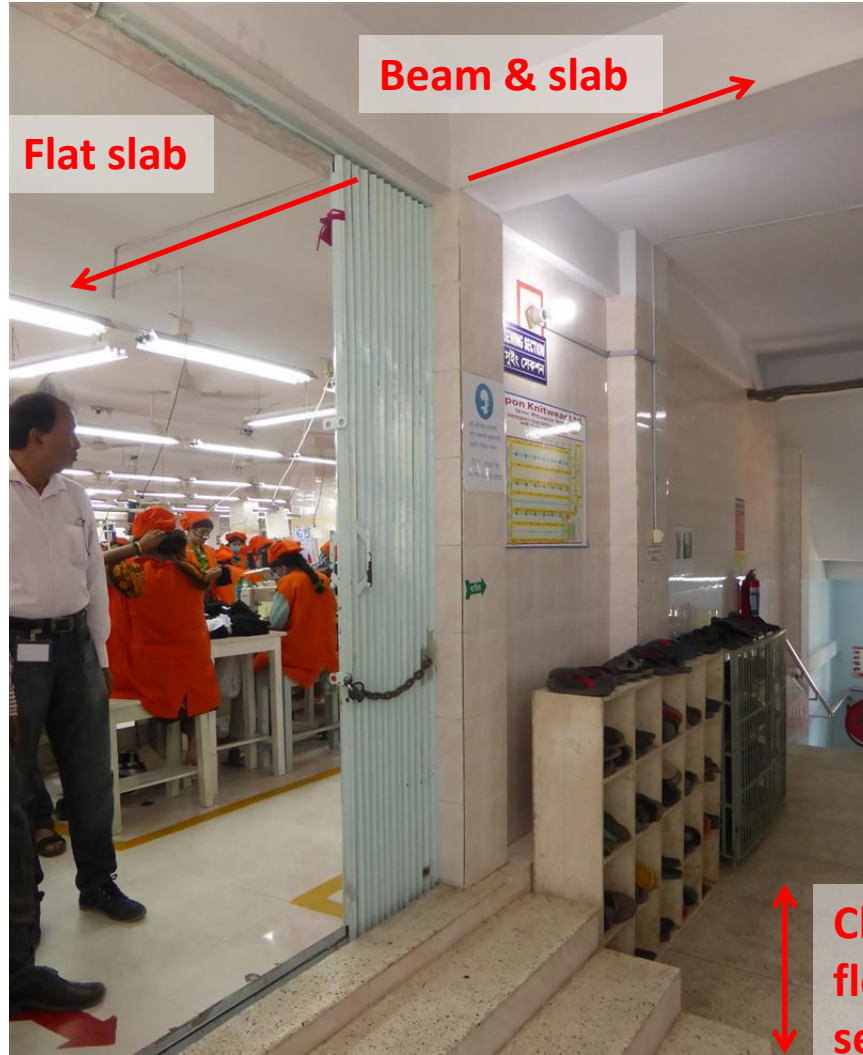
'Beam & slab' and 'flat slab' used at the same level. No structural engineering design information for flat slab system.

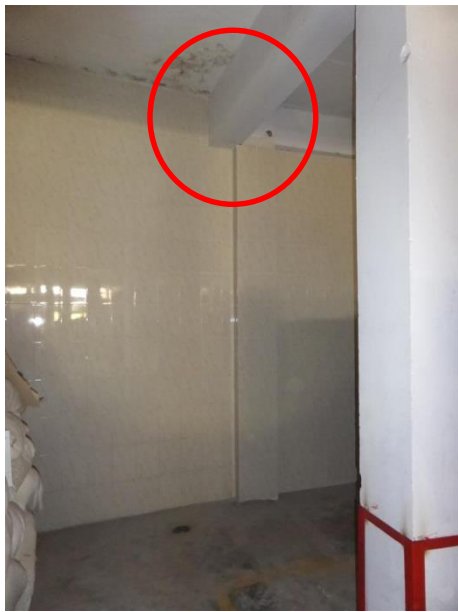
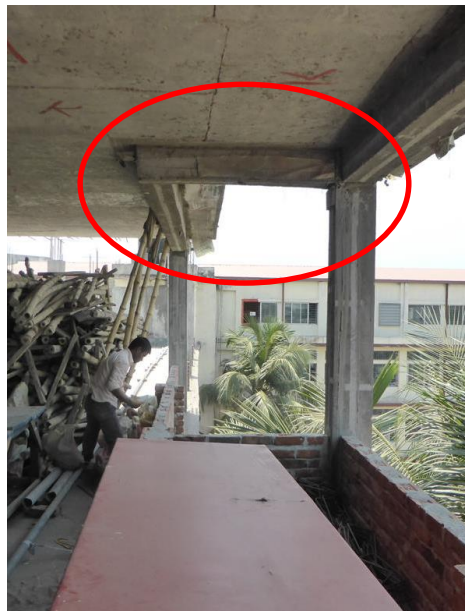
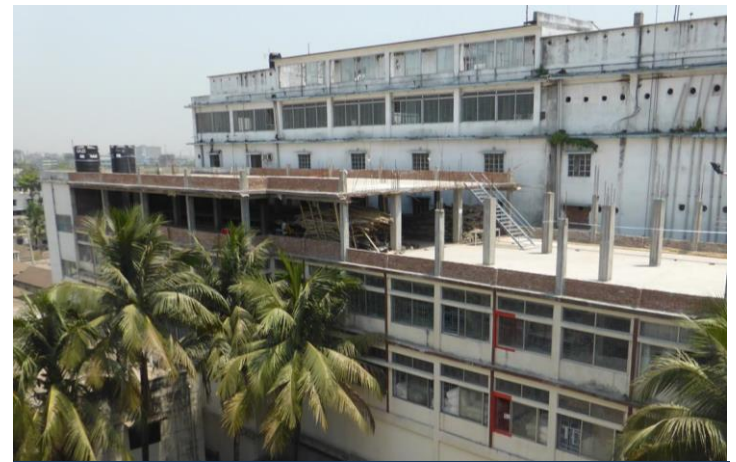
Flat slab construction at roof level ongoing. No structural design information available.

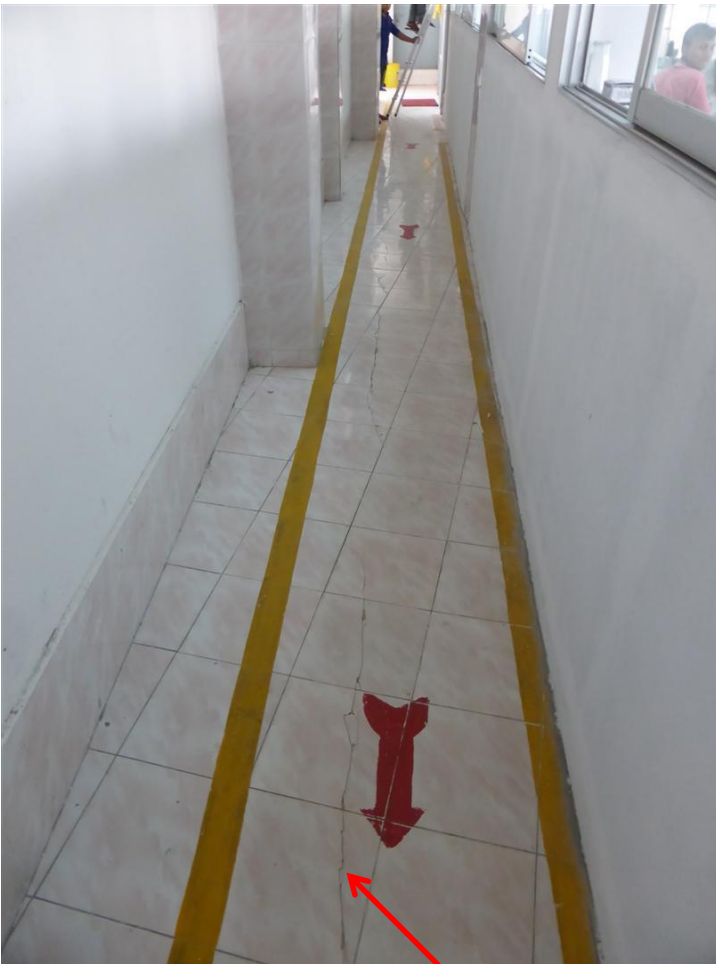
Generator House connected to main factory principally at fourth floor slab. Cracking observed in link slab.

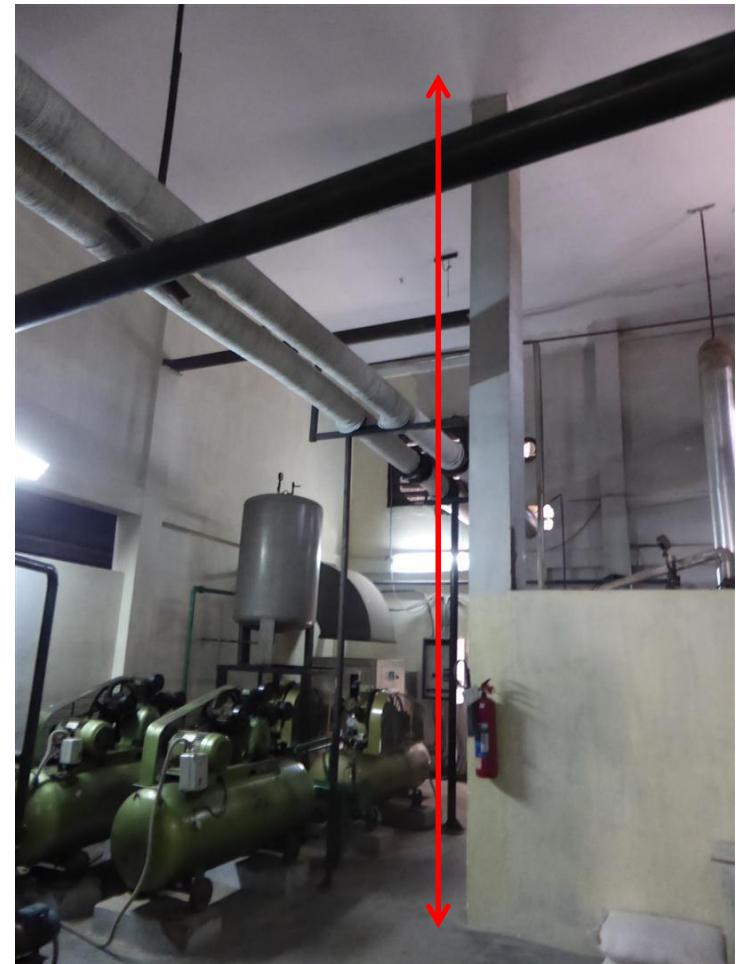
Double height space at ground floor. Stability provided by double height column and beam frame. Robustness of 4-storey moment frame (typically single bay with flat slab) unclear.

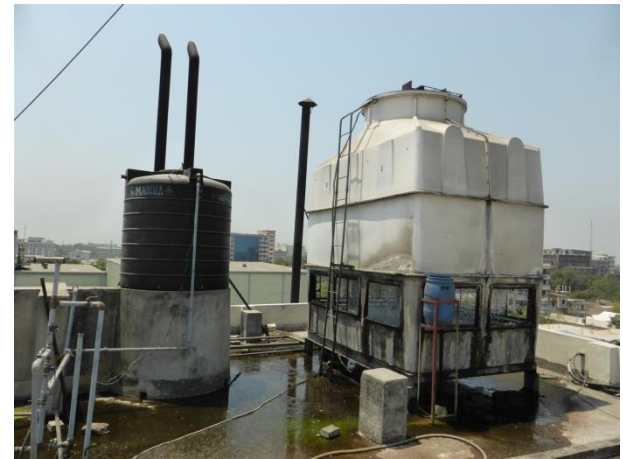
Localised areas of high loading

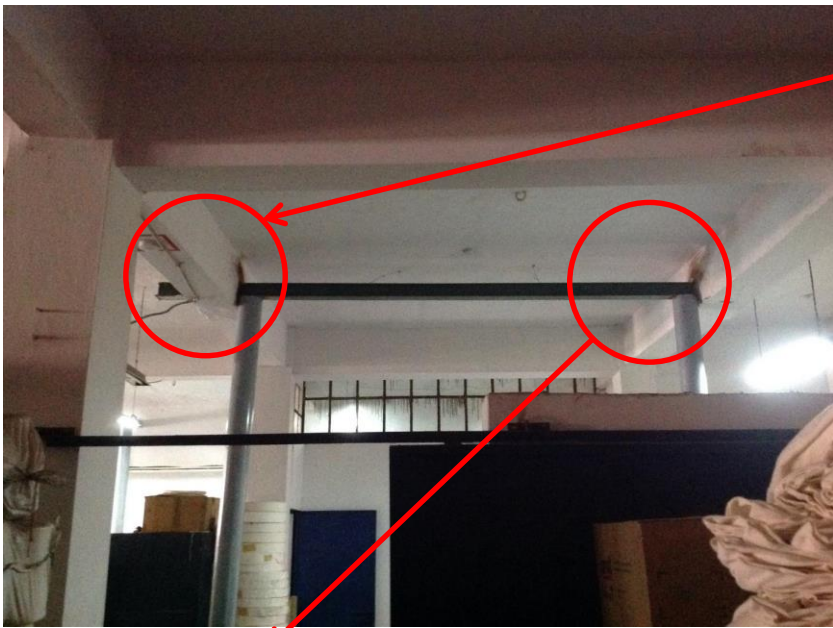
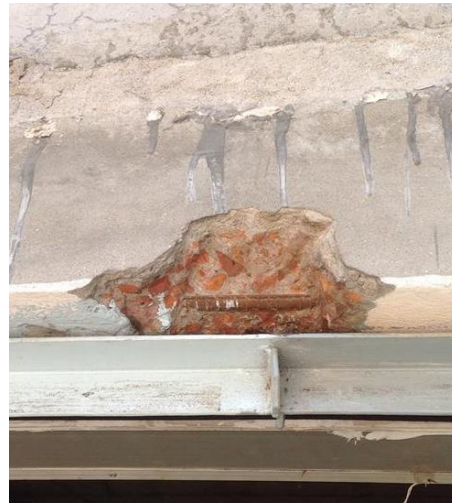
Some cracking observed in finishes, concrete slab soffits and damage to concrete cover zones.

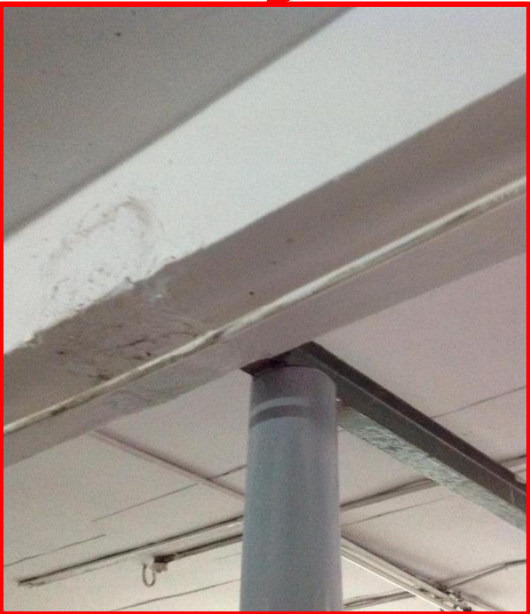
Damage to RC beams in a number of location due to installation of travelling cranes.

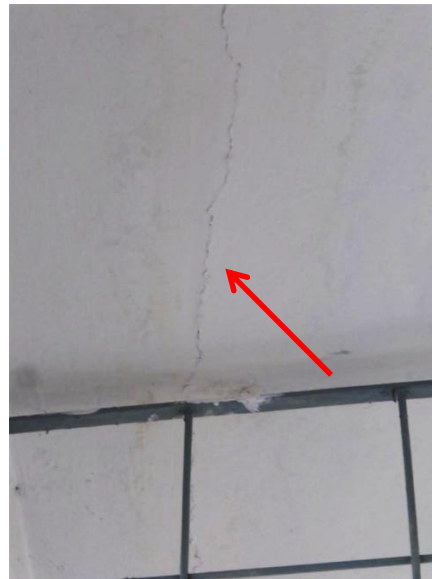
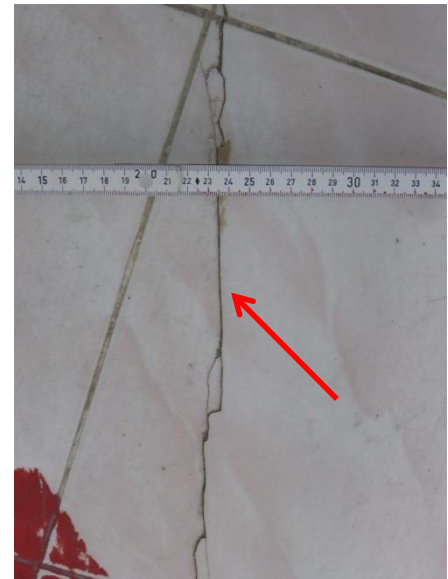
Damage to structural elements

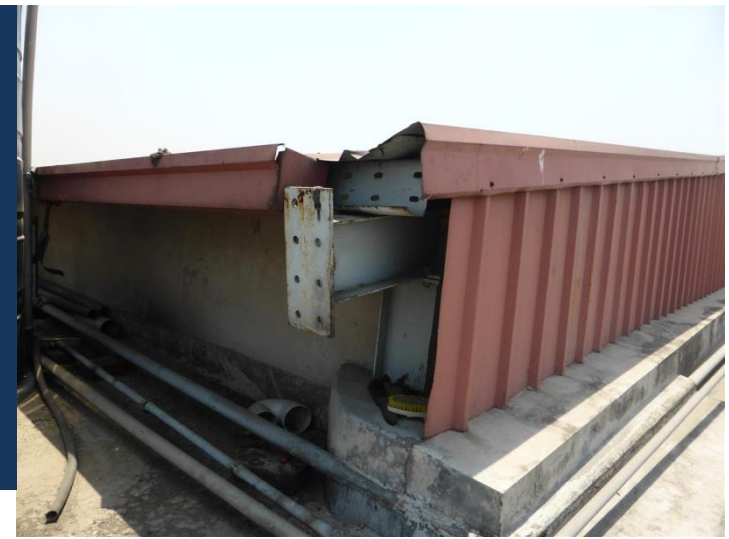
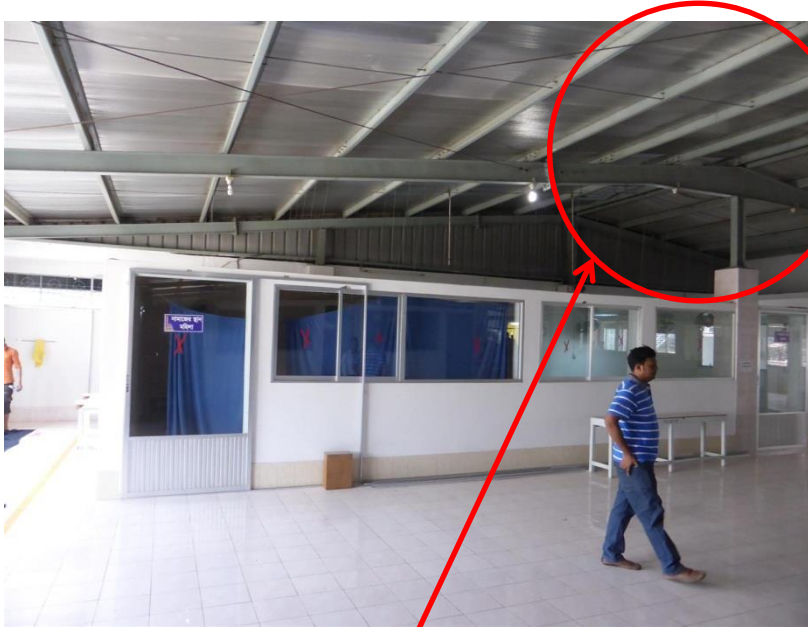
Incomplete braced bay in portal frame roof. Missing cross bracing ties.

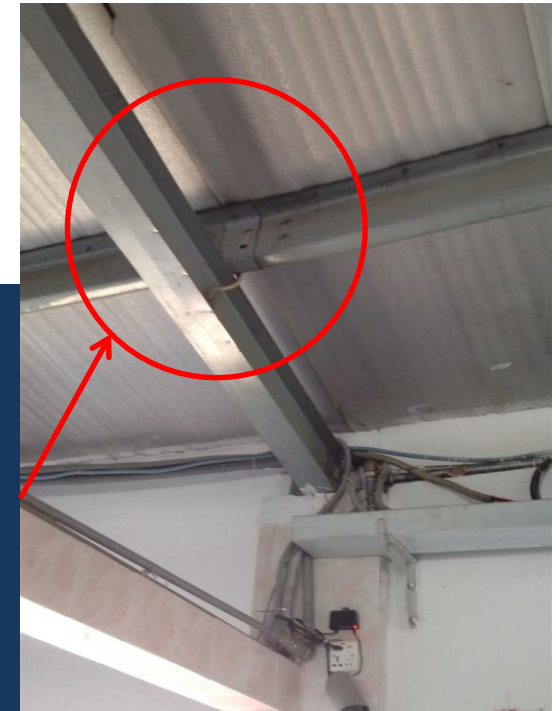
Canteen portal frame at roof level

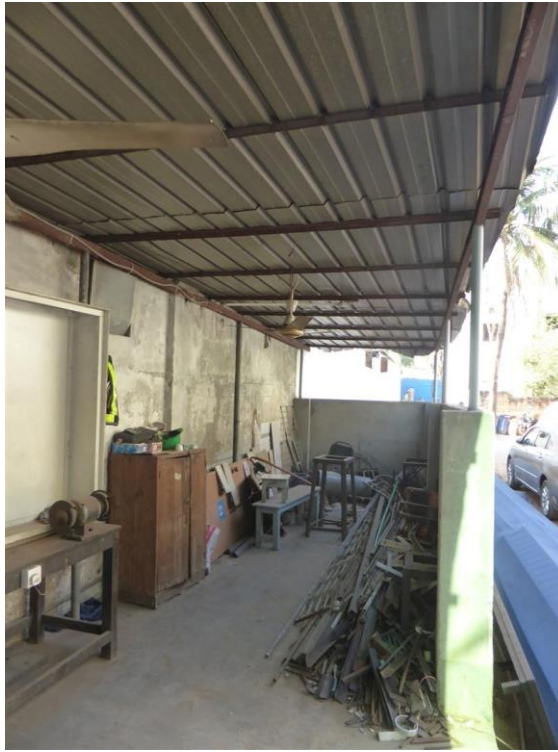
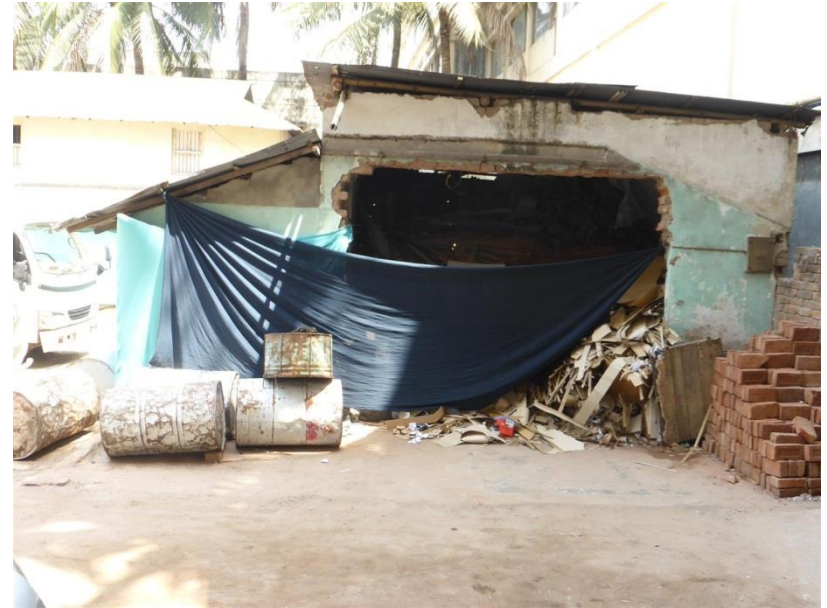
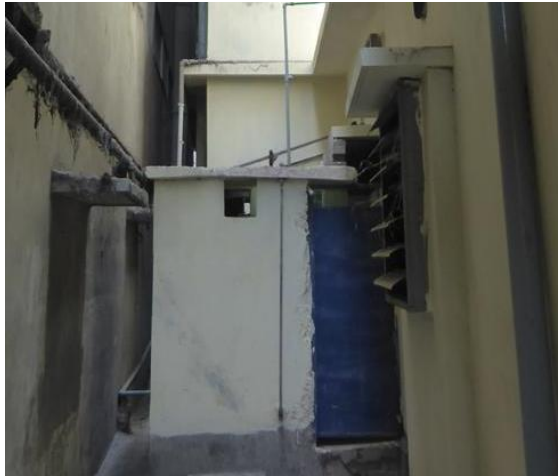
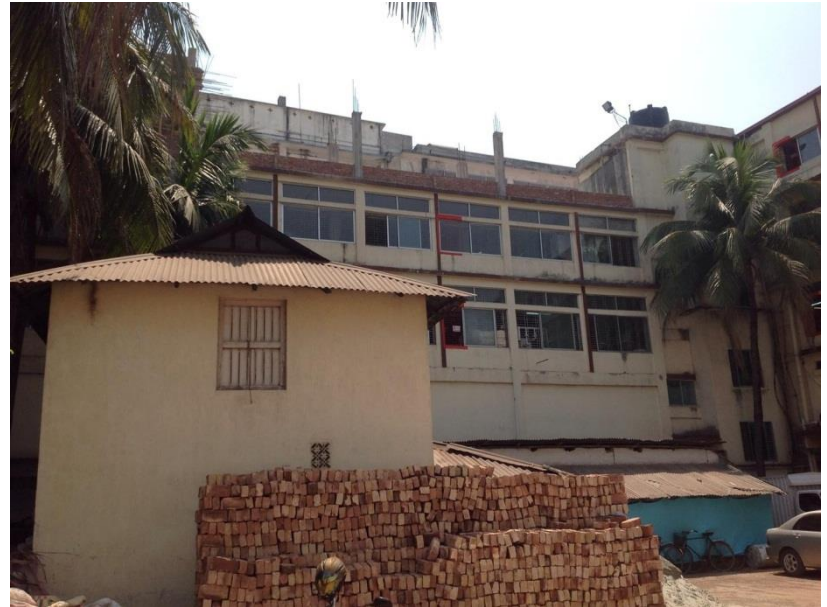
Non-engineered structures within the complex
